FOX LAKE LONG-RANGE AQUATIC PLANT MANAGEMENT PLAN UPDATE (2018-2022)

***THE FOX LAKE INLAND LAKE PROTECTION AND REHABILITATION
DISTRICT AND THE WISCONSIN DEPARTMENT OF NATURAL RESOURCES***

DECEMBER 14, 2017

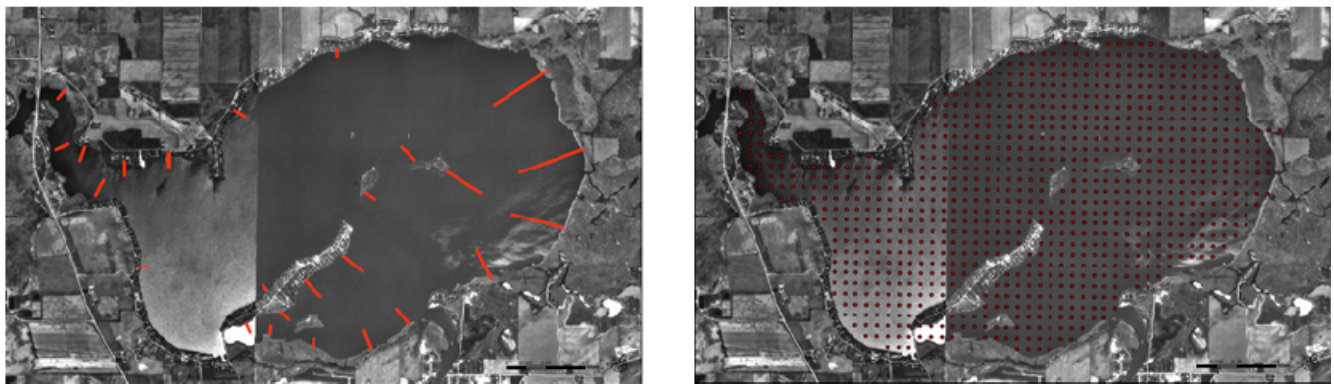
Figure 2-1
Comparison of Historic Transit Method to Point-Intercept Method
Source: WDNR and Hey and Associates, Inc.

Historically, the plant community on Fox Lake was surveyed using a transect-based technique (Figure 1 Left). Beginning in 2006 a new comprehensive point-intercept survey was started on the lake to provide a better overall picture of the aquatic plant community. Point-intercept surveys contain many more survey points than transect-based surveys (Figure 1 Right). The point-intercept survey method was repeated in 2007, 2008, 2013, and 2014.

The historic transects were recreated from the 2006 data from sampling locations from the point-intercept survey that roughly correspond to historic sampling locations; however, methodological differences do exist between the survey types. As a result, comparisons between 2006 through 2014 data and prior years are likely not as precise as comparisons between years where the transect method or point-intercept method was solely applied.

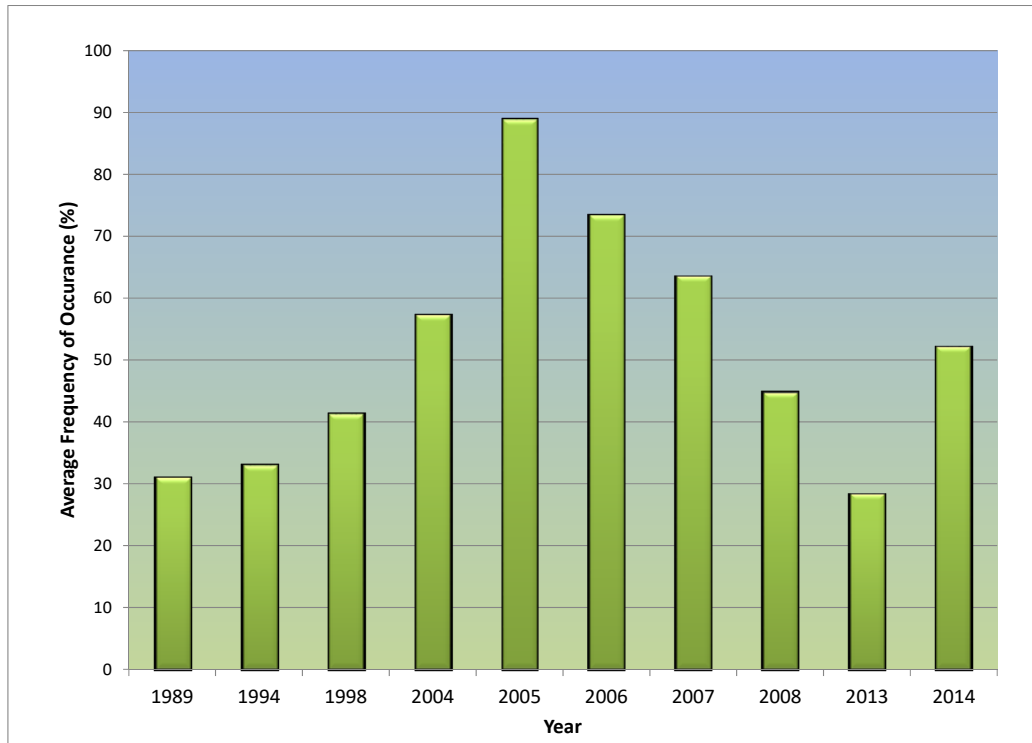
Figure 2-2
Frequency of Occurrence of Aquatic Plants Fox Lake
Source: WDNR, Hey and Associates, Inc., and Ecological Research Partners, LLC.

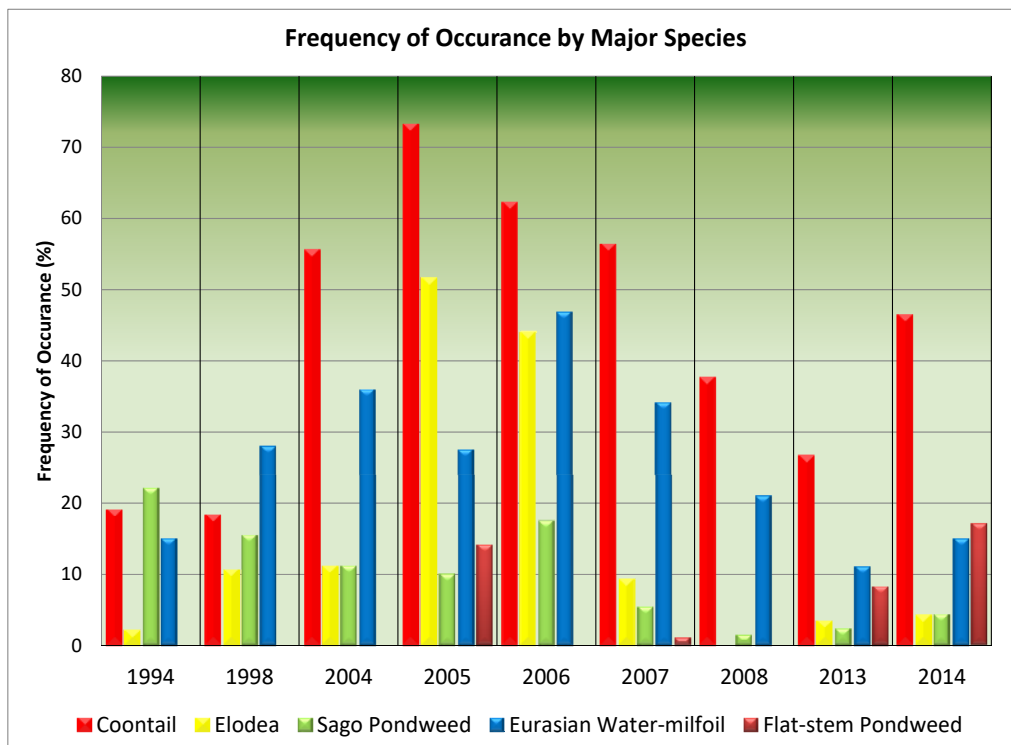
Figure 2-3
Frequency of Occurrence of Dominant Aquatic Plants
Source: WDNR and Hey and Associates, Inc

Figure 2-3 illustrates the trend in the dominant species in Fox Lake from 1998 through 2014. We see that the species of coontail, elodea and Eurasian water milfoil all expanded from 1998 through 2005, declined beginning in 2006 and in 2013, and expanded in 2014. Appendix B illustrates the distribution of the major species from 1996 through 2014.

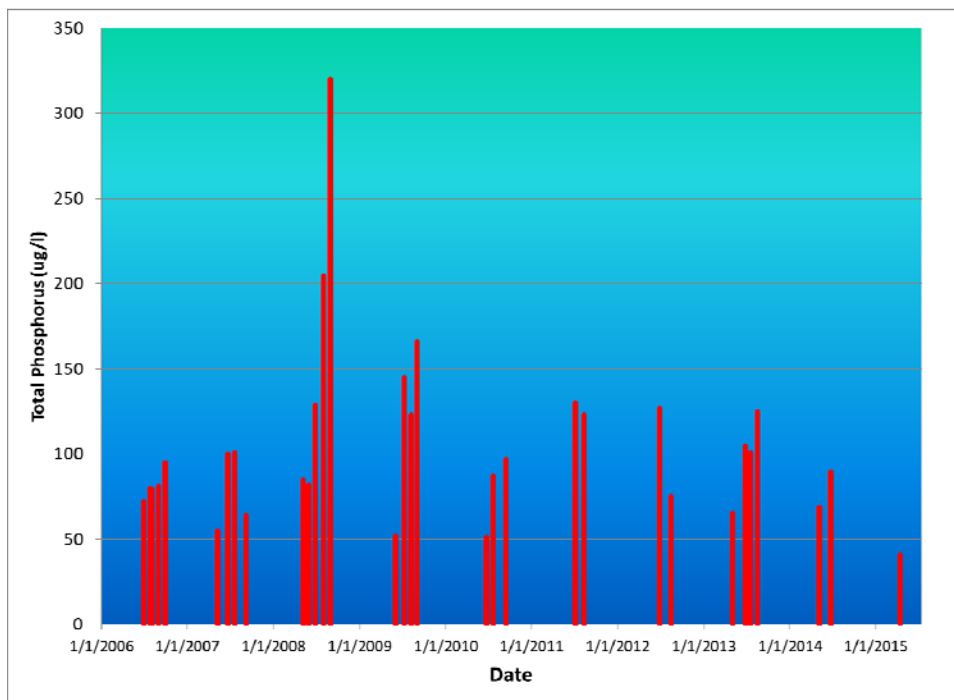
Figure 2-4
Fox Lake Total Phosphorus (Source: WDNR)

The steady decline of Fox Lake's water quality has been the focus of a number of studies. The studies indicate that Fox Lake is eutrophic to hyper-eutrophic and capable of a rapid transition from a clear water macrophyte dominated ecosystem into a turbid algal dominated system. Typical goals to manage a shallow eutrophic lake in the clear water state require total phosphorus <100ug/l (Scheffer et al. 1993 and Hosper and Meijer 1992). In-lake phosphorus concentrations ranging from 100 ug/l to greater than 300 ug/l during the summer months from 2006-2015 (Figure 2-4).

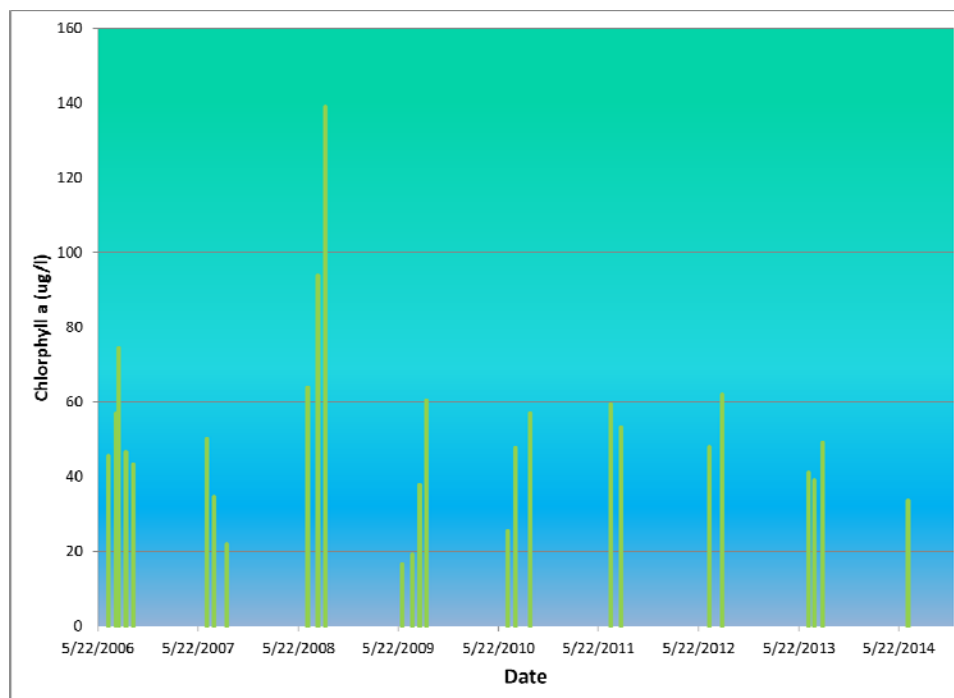
Figure 2-5
Fox Lake Chlorophyll-a (Source: WDNR)

Mean chlorophyll-a concentrations in Fox Lake range from less than 20 ug/l to as high as 140 ug/l during the summer months from 2006 to 2014 as illustrated in Figure 2-5.

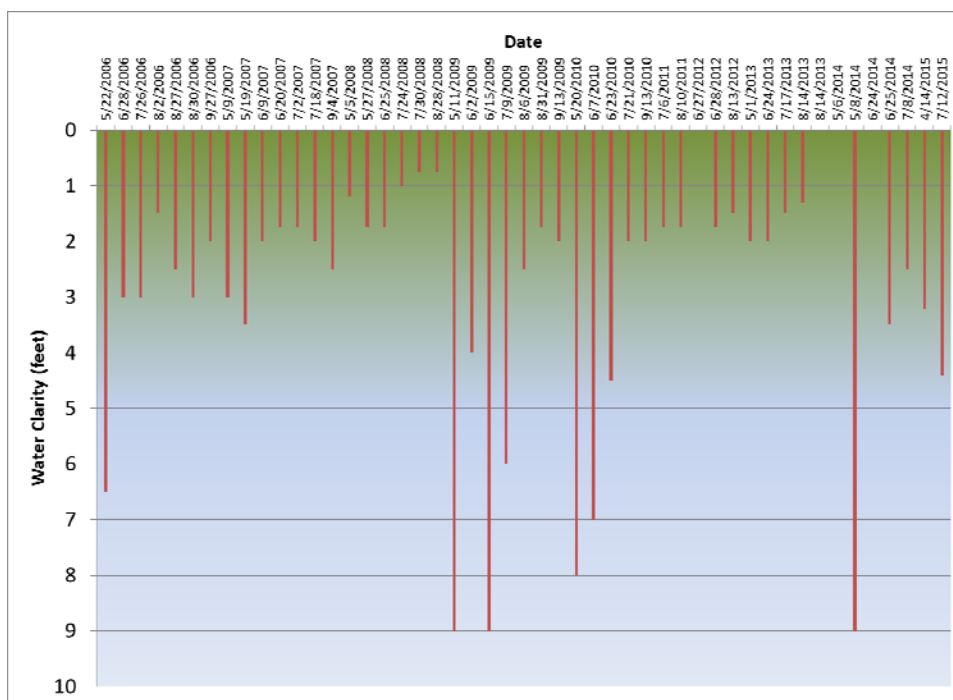
Figure 2-6
Fox Lake Secchi Depth (Source: WDNR)

Secchi disk readings from 2006-2015 were generally poor, less than two feet in mid-summer (Figure 2-6). Spring values in 2009, 2010 and 2014 did reach as much as 8 and 9 feet, however, the lake did not stay clear for the entire summer.

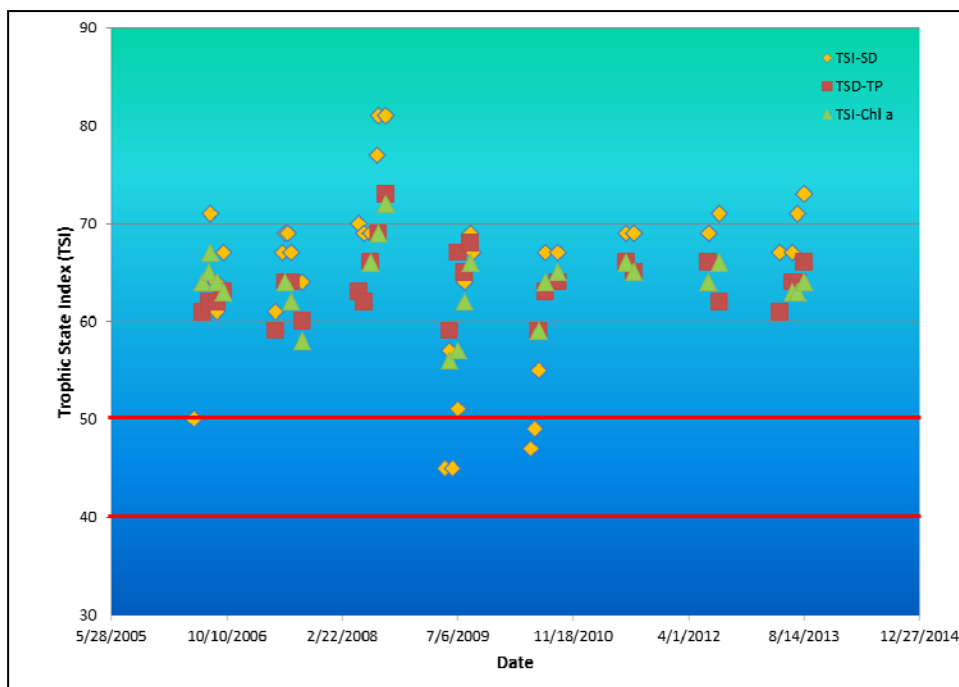
Figure 2-7
Trophic State Index Values 2006 to 2013 Fox Lake (Source: WDNR)

Analysis of Trophic State Index values for chlorophyll-a, Secchi disk, and total phosphorus indicate that Fox Lake is eutrophic and that lake turbidity may be due to more than just high algal populations, but may be augmented by suspended sediment from nonpoint source pollution and re-suspension of bottom sediment by wind and bottom feeding fish activity (Figure 2-7).

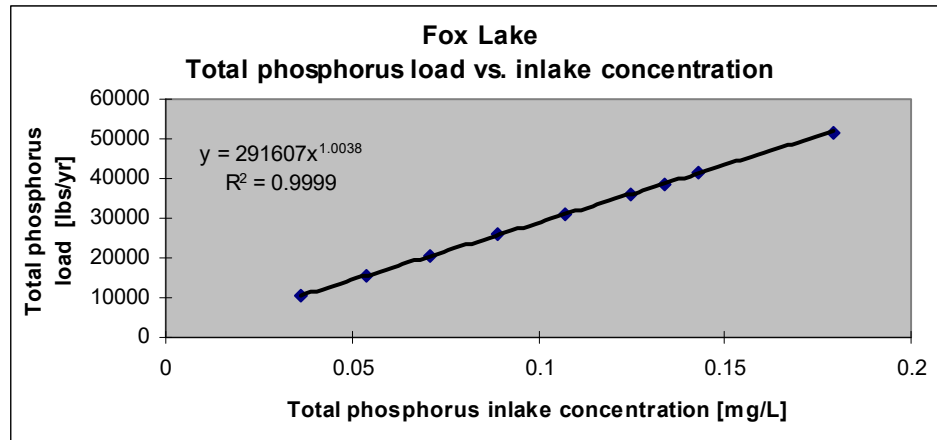
Figure 2-8
 Trophic Model for Fox Lake

A trophic model was developed for Fox Lake to determine the relationship between watershed loading and in-lake measurements of total phosphorus. The model is shown in Figure 2-8. The watershed loadings for total phosphorus should be below 30,000 pounds per year to maintain the clear water state (TP<0.1 mg/l or 100µg/l).

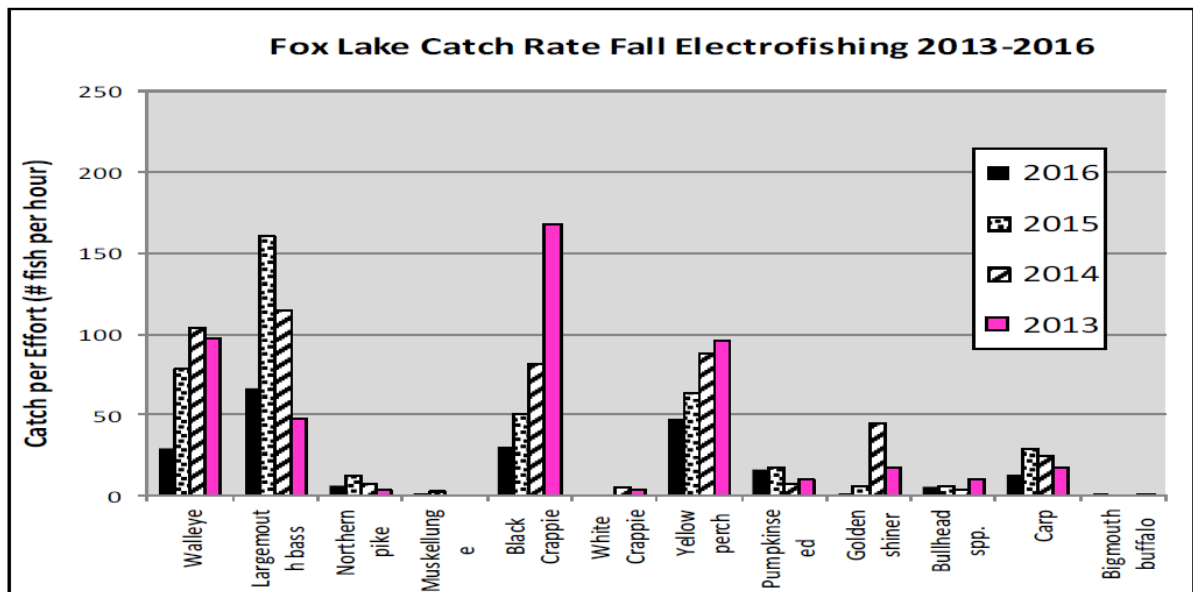
Figure 2-10
Results of Annual Electrofishing Surveys Fox Lake 2013-2016
Source: WDNR

The fishery of Fox Lake is samples annually by the WDNR staff from the Horicon area office. The results of monitoring from 2013 through 2016 are illustrated in Figure 2-10. Results for key fish species are summarized in Table 2-7 for 2010 through 2016. The results show a general decline in walleye, largemouth bass and black crappie numbers from 2010 to 2016, a large increase in yellow perch numbers in 2016, and generally low numbers of bullhead and carp.

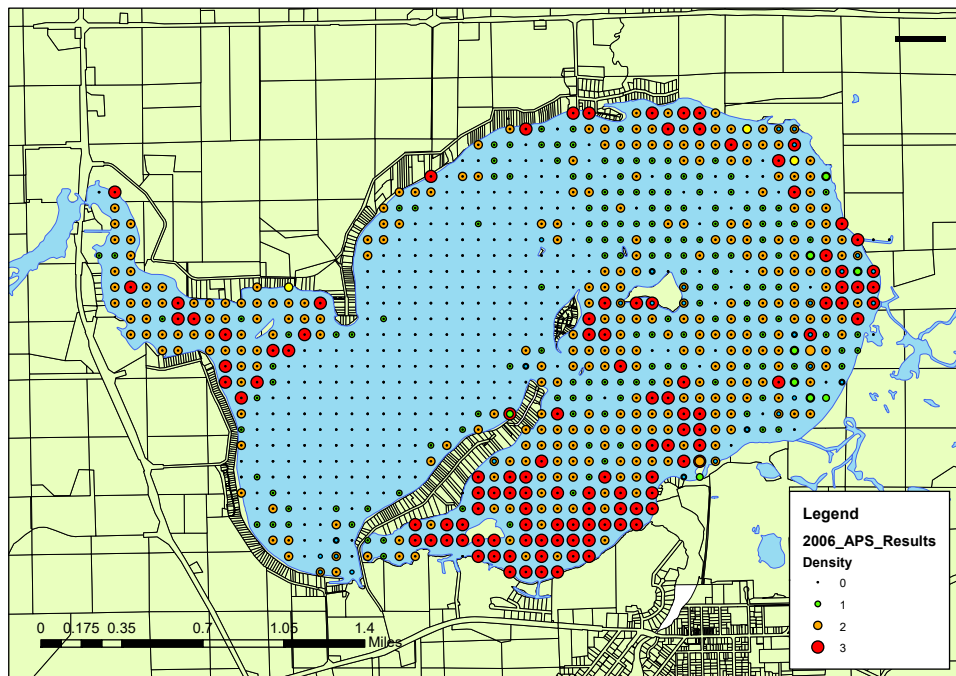
Figure 3-1
2006 Nuisance Plant Areas Indicated by Total Plant Density (Red Dots)
Source: Hey and Associates, Inc

found in 2006. The areas of the lake supporting dense plant growth were shallow littoral areas with a silty bottom. Figure 3-1 shows the locations of nuisance plant areas in 2006. Nuisance conditions are defined as areas of the lake where recreational uses such as swimming, boating, and fishing are impeded.

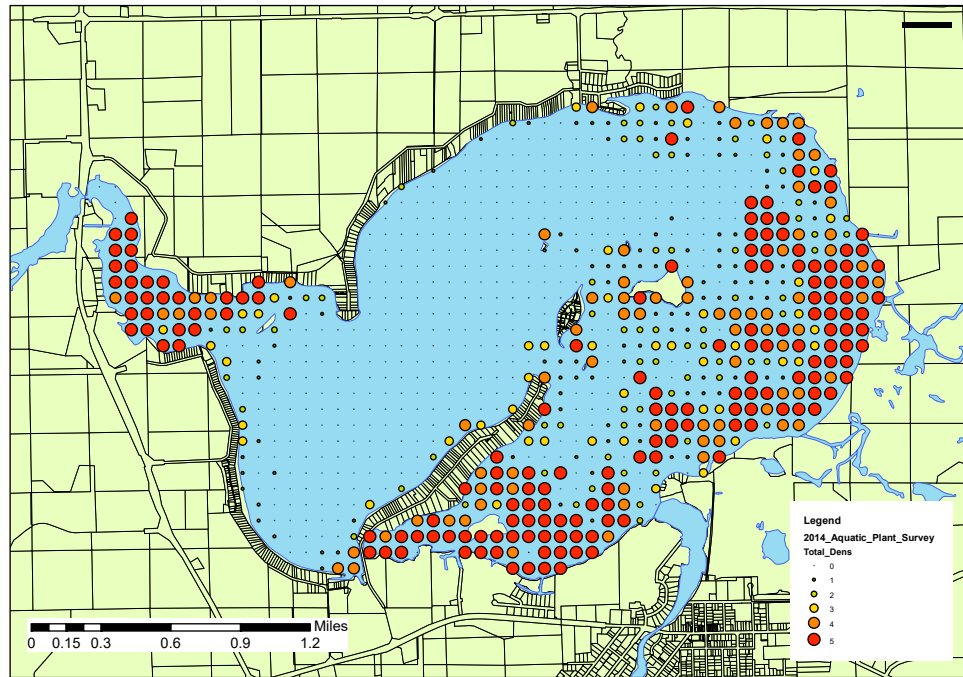
Figure 3-2
2014 Nuisance Plant Areas Indicated by Total Plant Density (Red Dots)
Source: Ecological Research Partners, LLC.

Following 2006, the plant community began to decline in density. The frequency of occurrence of plants dropped from 73.4 in 2006, to 63.6 in 2007, 44.8 in 2008, and 28.4 in 2013. Plant abundance increased in 2014 with frequency occurrence rebounding to 52.2%. The greatest reduction in aquatic plants during turbid years is typically in the eastern half of the lake. The inlet areas on Cambra and Alto Creeks have maintained their plant communities through changes in lake turbidity, likely due to the clear water inputs from these streams during base flow. Figure 3-2 illustrates the areas with dense aquatic plants in 2014, the last aquatic plant survey.

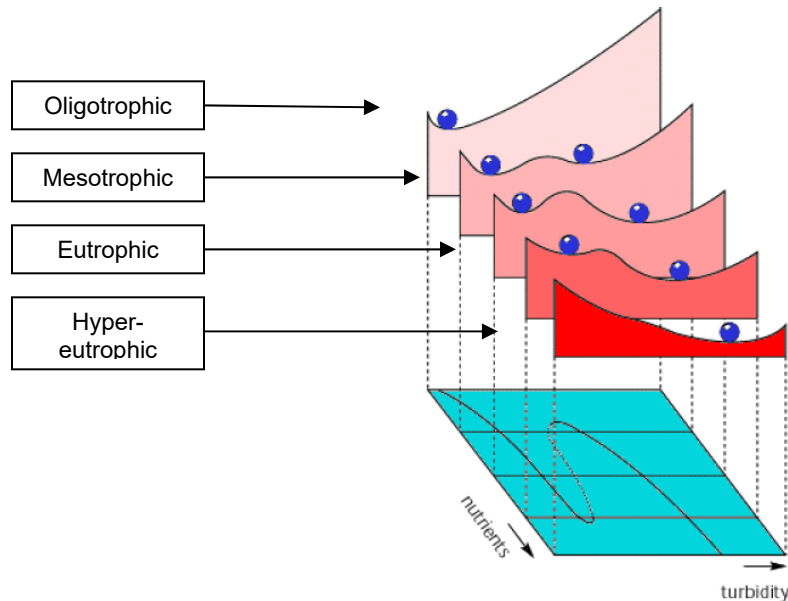
Figure 3-4
"Ball and Cup" model of alternate stable states (left side of model is clear water state)
Modified from Sheffer 2001

As Figure 3-4 shows, the clear or turbid water state depends on the abundance of nutrients and turbidity. The location of the ball in the model represents the probability that a given state will occur with a combination of nutrient and turbidity conditions. The vertical height of the ball location represents the preferred state of the system at any given time where the lower position is more likely to occur. The humps in the model represent the amount of energy or management required to switch to the alternate stable state. It is clear from this graphical representation that it is unlikely for a hyper-eutrophic lake to persist in the clear water state without management.

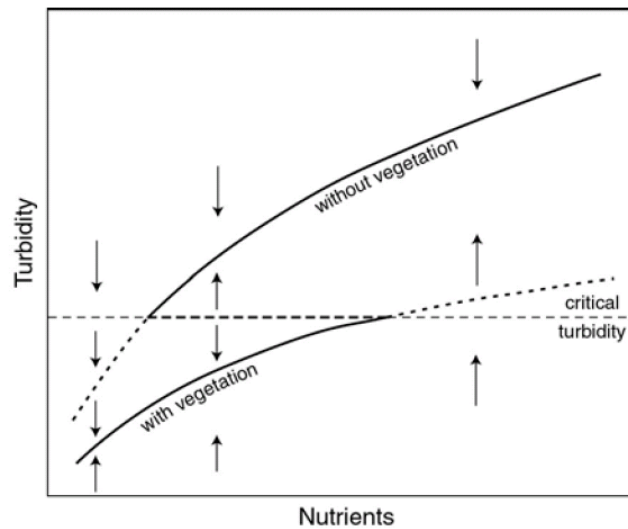
Figure 3-5
Graphical model of interaction for turbidity and nutrients for
lakes between alternate stable states
Source: Sheffer 2001

Characteristics of the clear water state include abundant aquatic plant growth, a diverse and productive gamefish community, and numerous zooplanktons while the turbid state is free of aquatic plants, produces dense algae populations, and supports an undesirable, bottom-feeding fish population (Jeppesen et al. 1990, Hasler and Jones 1949, Wetzel 1996, Van Donk et al. 1993, Kufel and Ozimek 1994, Timms and Moss 1984, Schriver et al. 1995). One of these states *will* occur in shallow hyper-eutrophic lakes. An alternate version of the alternate stable states model is depicted in Figure 3-5.

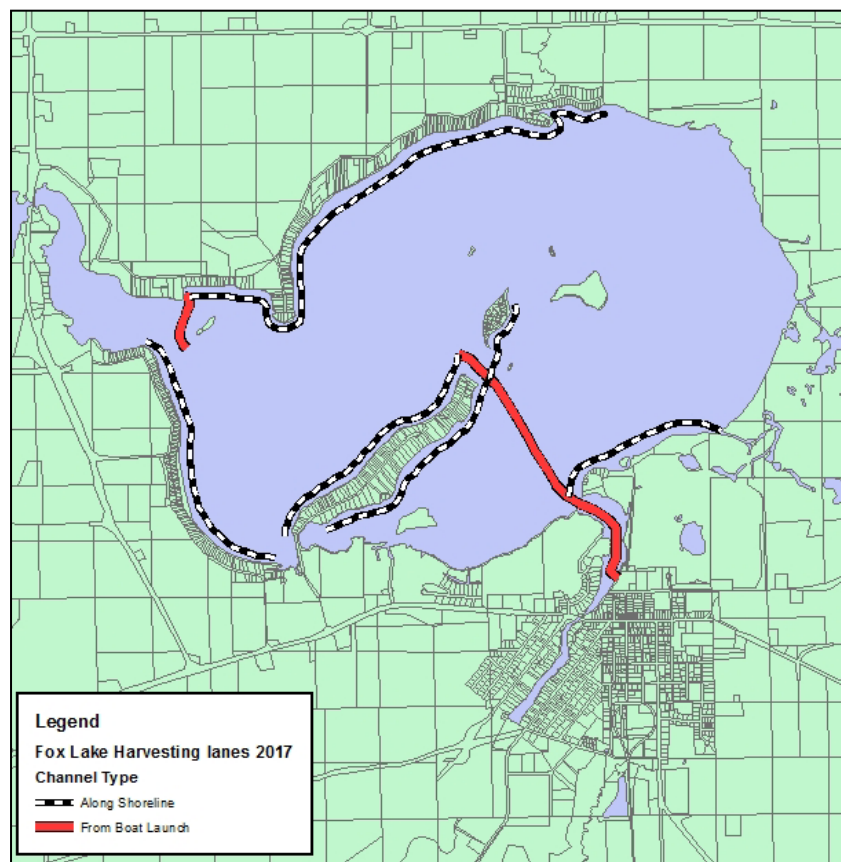
Figure 3-7
Proposed Navigation Channel Locations
Source: Ecological Research Partners, LLC.

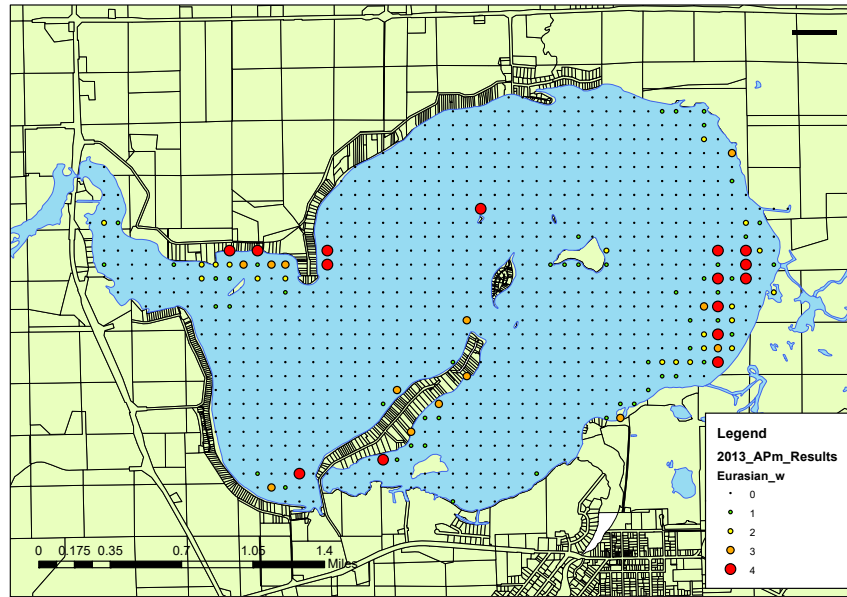
Figure 3-8
Priority Eurasian water-milfoil Management Areas Based on 2014 Conditions
Source: Ecological Research Partners, LLC.

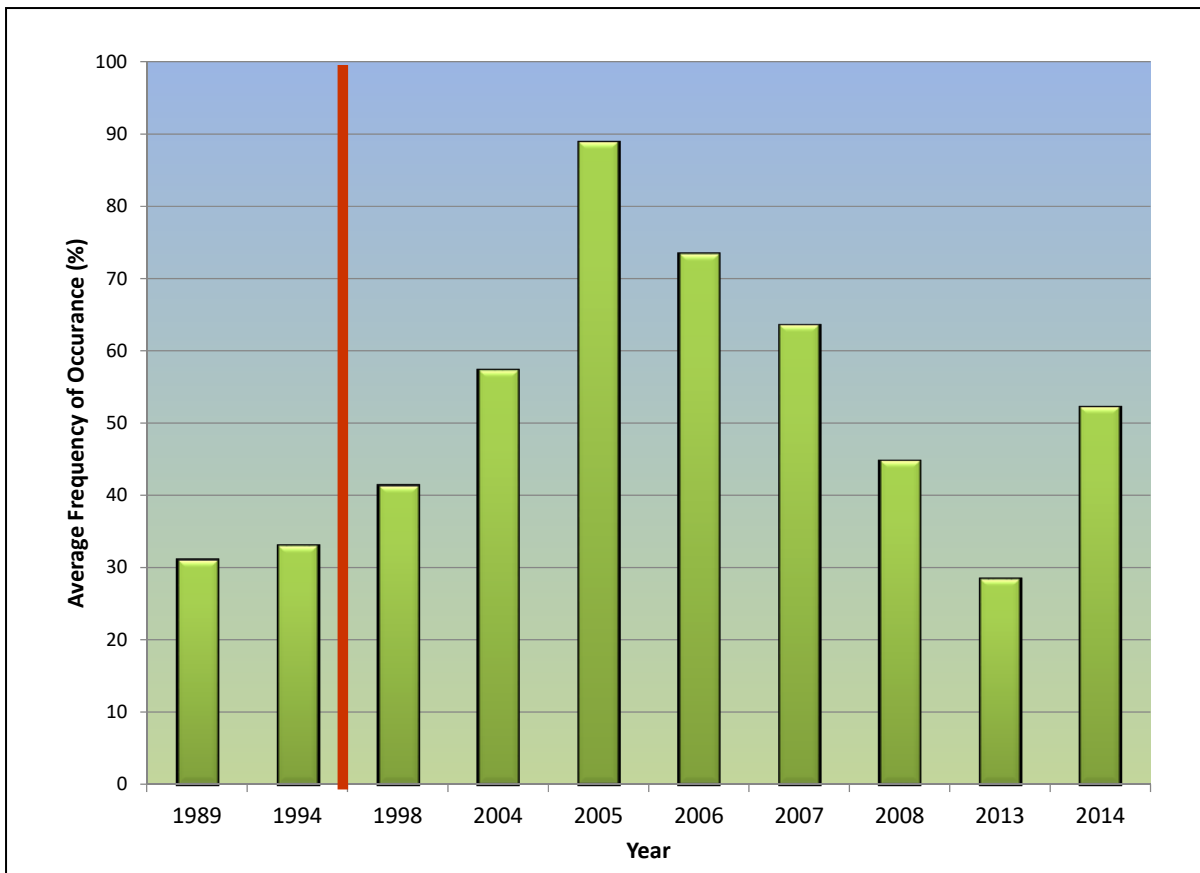
Figure 4-1
Average Frequency of Occurrence of Rooted Aquatic Plants Fox Lake
1989 through 2014

As Figure 4-1 illustrates Fox Lake can flip-flop from clear water years with abundant rooted aquatic plants, to years dominated by dense algal blooms and limited rooted plants in the lake. The cause of the varied abundance of aquatic plants from year to year may be due to variability in spring surface water runoff from the lake's watershed and varying ice clarity from the prior winter.

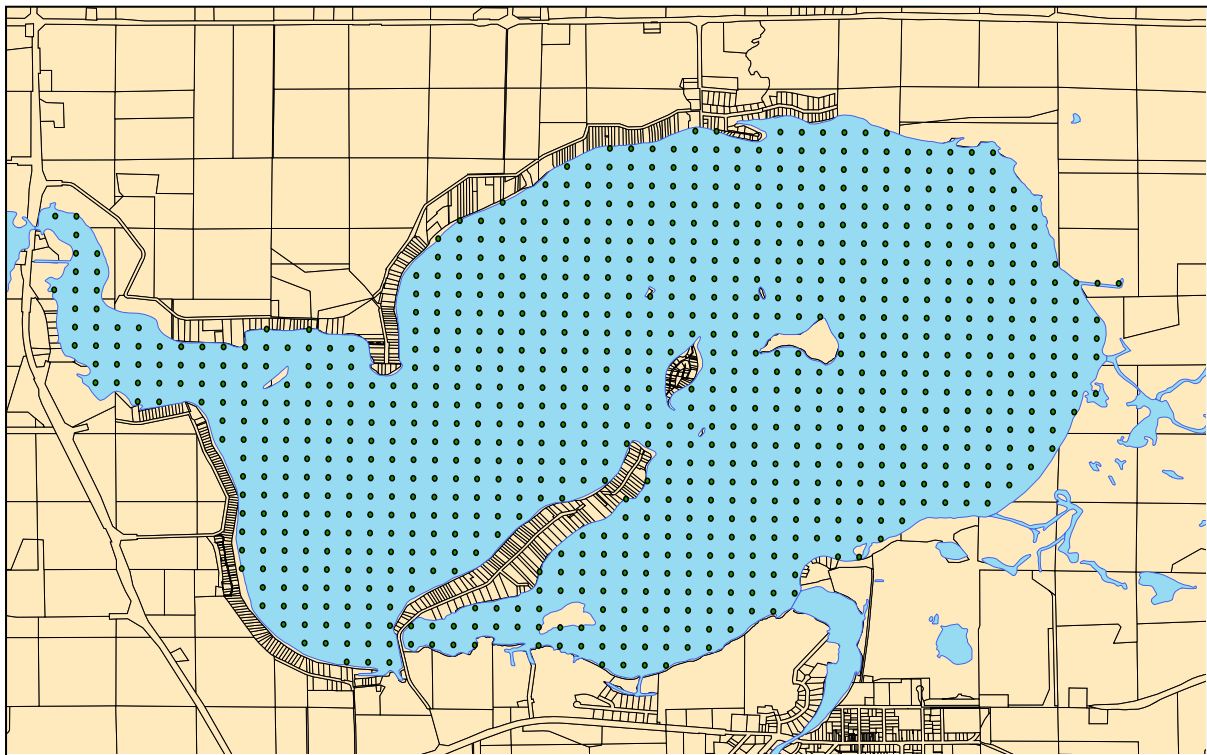
Figure 4-3
 Rooted Aquatic Plant Sampling Sites on Fox Lake

Established rooted aquatic plant sampling sites are illustrated in Figure 4-3.

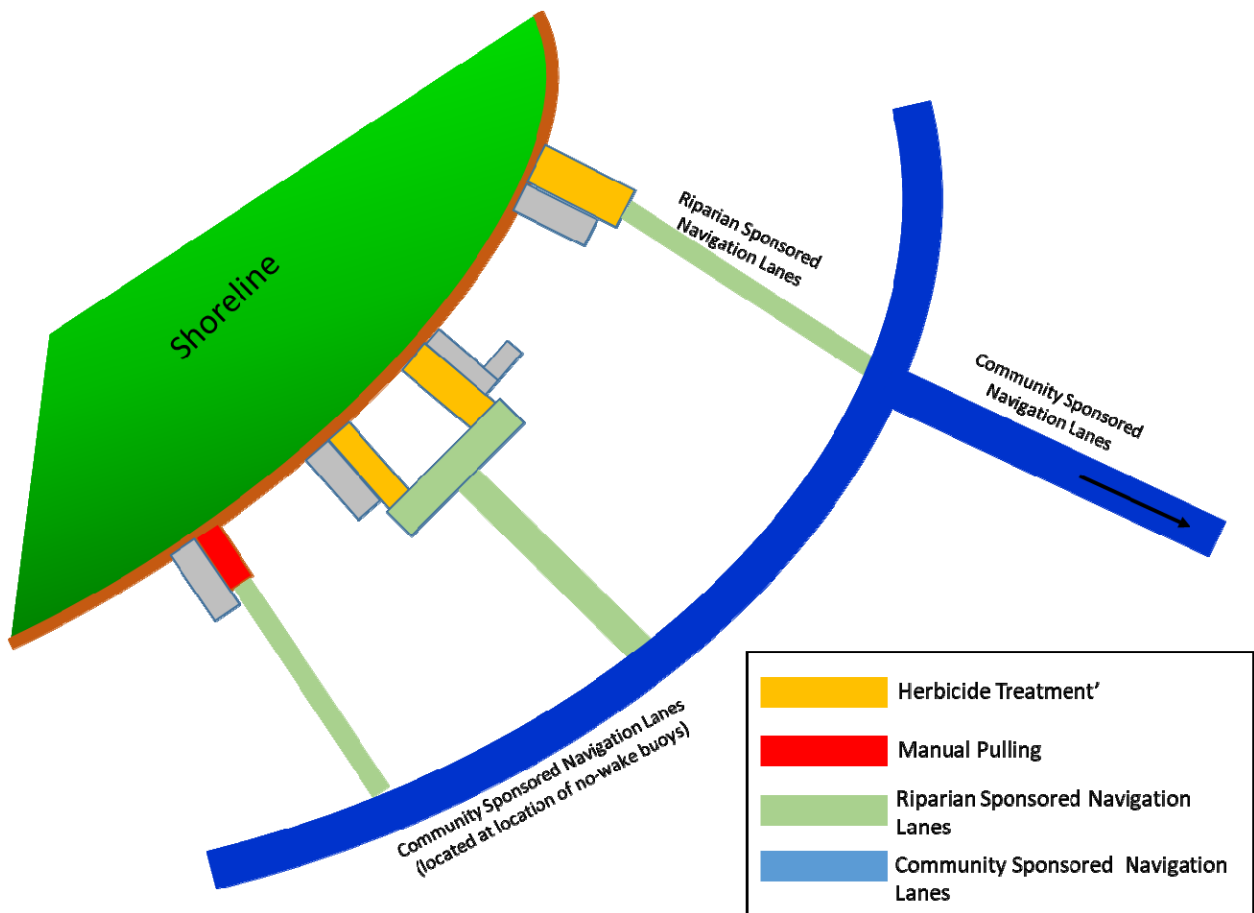
Figure 4-5
Integrated Aquatic Plant Management Strategy
Source: WDNR and Ecological Research Partners, LLC.

An integrated aquatic plant management strategy (Figure 4-4) applies a number of different methods to effectively allow recreation while maintaining ecological benefits. For Fox Lake, this management strategy will require a combination of low and high-level manipulation including manual pulling, herbicides, and mechanical harvesting. This strategy focuses on minimizing the impact to native plants, reducing invasive species such as Eurasian watermilfoil (EWM) in select areas, and promotes lake access and recreational use. The management can be broken down into practices for nearshore areas near piers and shorelines, and offshore management to allow navigation to open water.

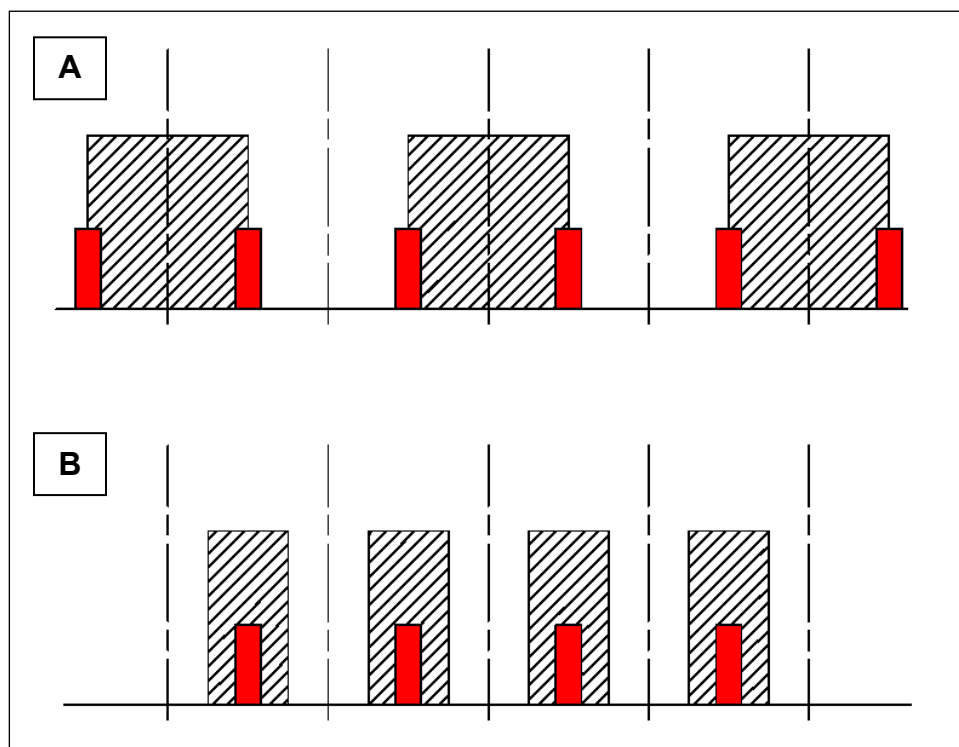
Figure 4-6
Alternate Contact Herbicide Application Strategy (not to scale)
Source: Ecological Research Partners, LLC.

Note that if you use a combination of techniques the waiver for a permit for manual pulling no longer exists and a state permit will be required. With regards to nearshore navigation lanes, these can be created and maintained by either mechanical harvesting or chemical herbicides. Neighboring property owners can also work together to create common riparian sponsored navigation lanes or swimming areas (Figures 4-5 and Figures 4-6).

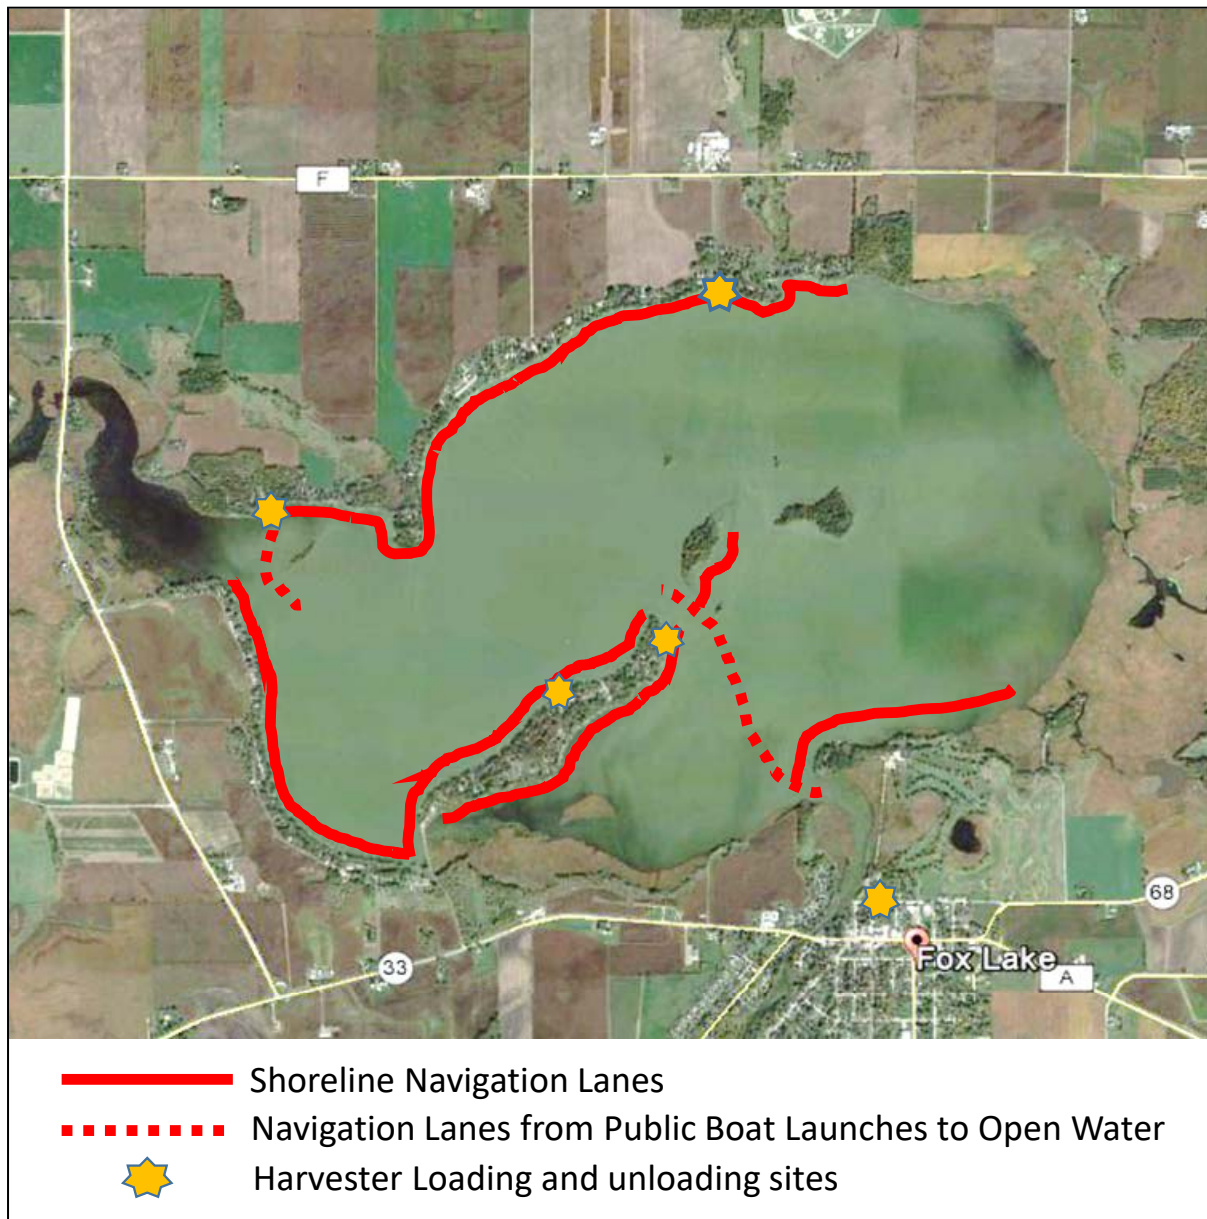
Figure 4-7
Proposed Navigation Channel Locations & Potential Location of Harvesting Loading and Unloading Sites

the Town of Fox Lake's no-wake buoys to help mark the location of the channels. The locations of the channels are illustrated in (Figure 4-7). The location of these channels may be modified from year to year depending on plant densities and nuisance conditions.

The community sponsored navigation channels will be 50-foot wide located just inside the no-wake buoys to facilitate the passing of two boats. No-wake speeds are approximately 20 mph. The channels will be created in May or June when plants become abundant and maintained with up to two additional cuttings if needed, for a maximum of three cuttings per year. The need for harvesting will be based on surveys conducted by the Fox Lake Inland Lake Protection and Rehabilitation District (FLILPRD) or its designated representative. Harvesting will take place when the plant growth interferes with navigation and the harvesting contractor is available.

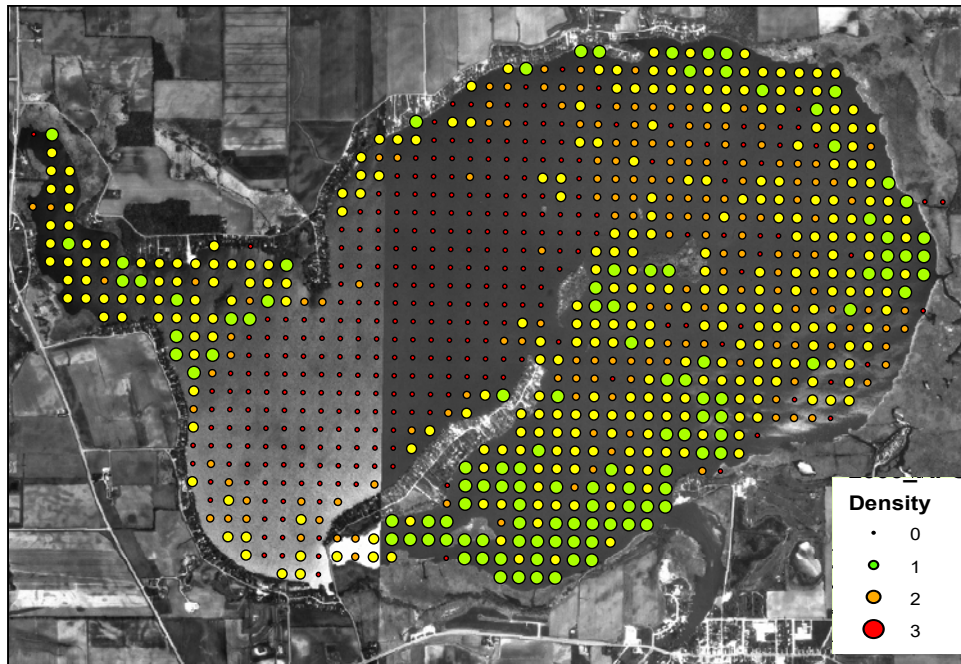
Figure 4-8
Lake-wide Eurasian water-milfoil Distribution 2006
Source: Hey and Associates, Inc.

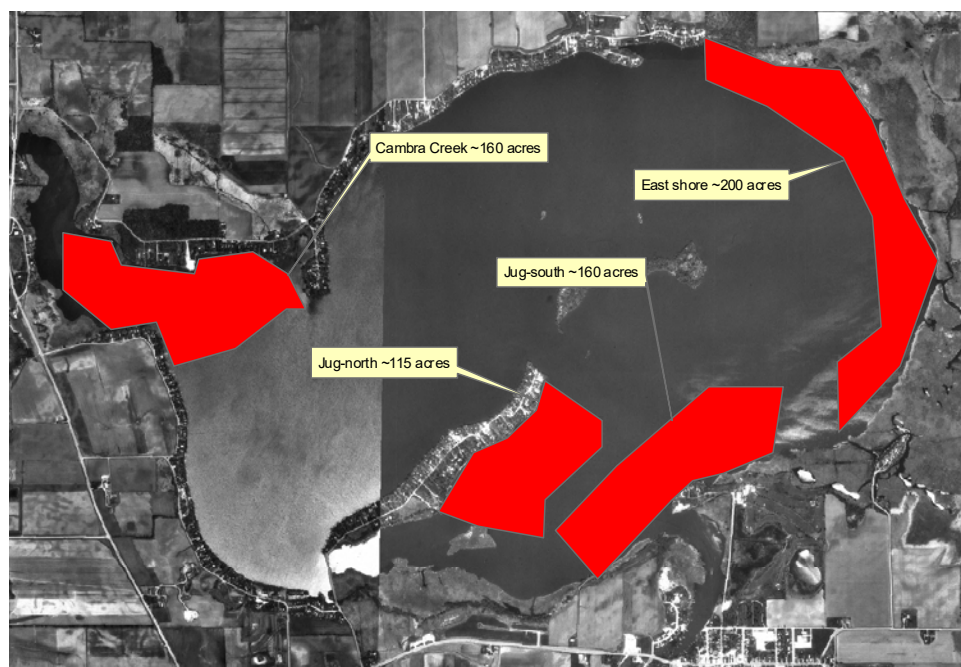
Figure 4-9
Potential Lake-wide Eurasian Water-milfoil Control Areas Based on 2007 Conditions
(Treatment Areas are shown in Red)

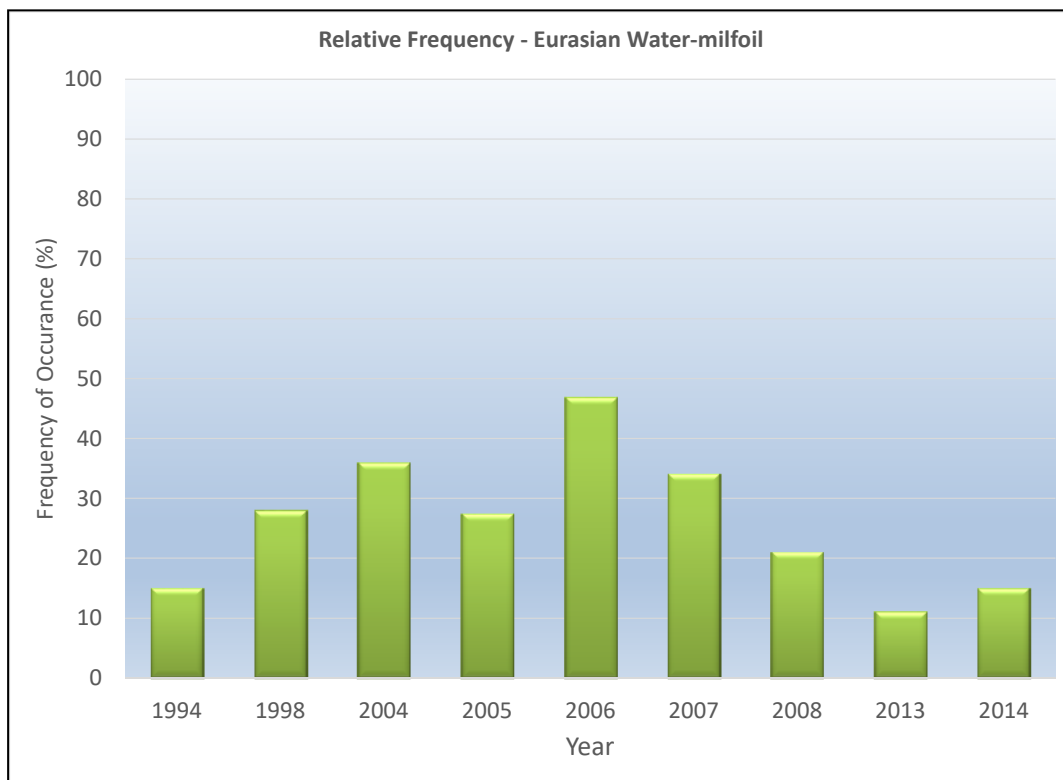
Figure 4-10
Abundance of Eurasian Water-Milfoil 1994 through 2014
Source: Ecological Research Partners, LLC.
